PHOTOGRAPHIC INTERPRETATION REPORT

YEDROVO ICBM COMPLEX USSR

LAUNCH SITE 23

JULY 1966

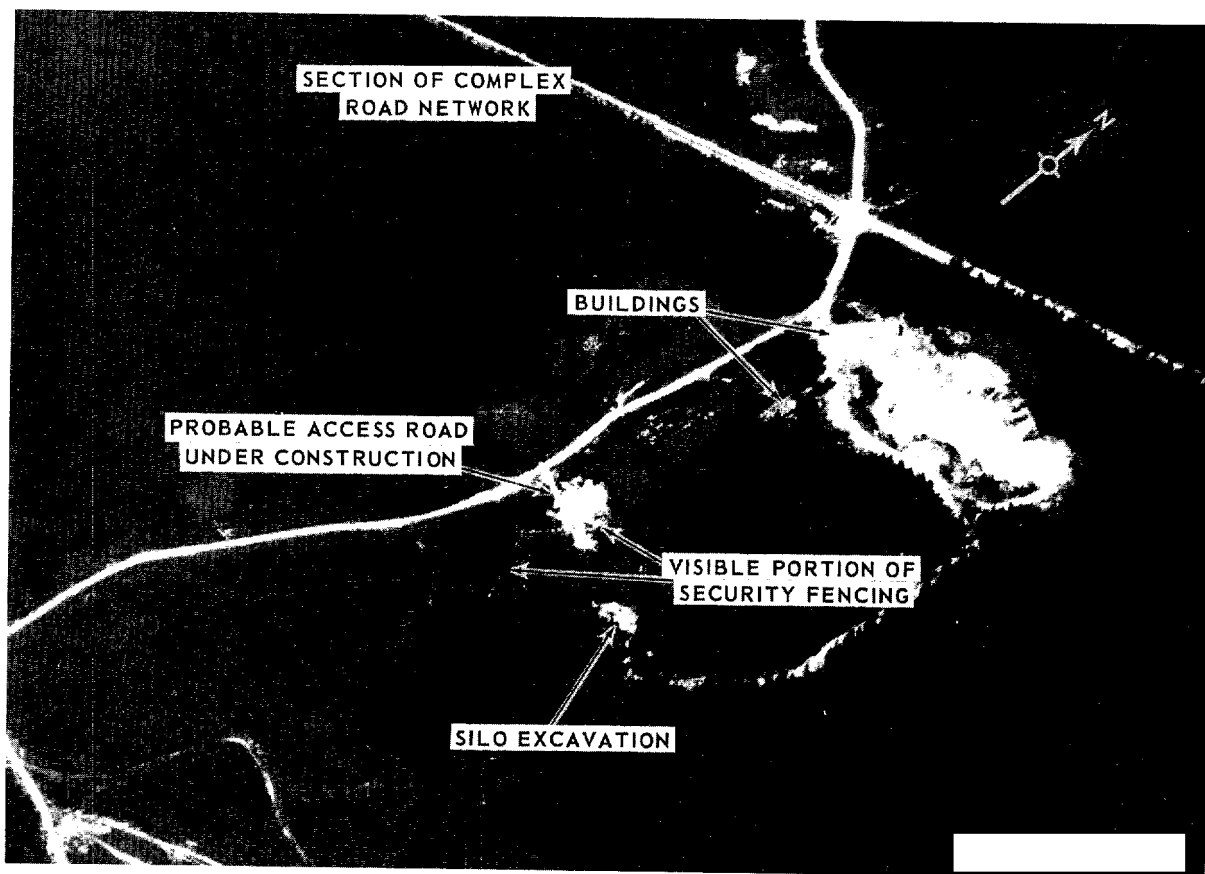
Location: Approximately 10.0 nm W of the complex support facility

Type: IIID

Stage of Construction: Early

The launch site consists of a silo excavation and 2 buildings. A portion of the security fencing is visible. A probable access road under construction extends from the silo excavation to a nearby road.
